Errata Sheet

June 18, 2001 / Release 1.2

Device:	SAK-C167CR-L(33)M, SAF-C167CR-L(33)M, SAB-C167CR-L(33)M SAK-C167CR-4R(33)M, SAF-C167CR-4R(33)M, SAB-C167CR-4R(33)M SAK-C167CR-16R(33)M, SAF-C167CR-16R(33)M, SAB-C167CR-16R(33)M SAK-C167SR-L(33)M
Stepping Code / Marking:	ES-GA, GA, GA-T, GA-T 6 ES-JA
Package:	P-MQFP-144-1, P-MQFP-144-6 (GA-T 6)

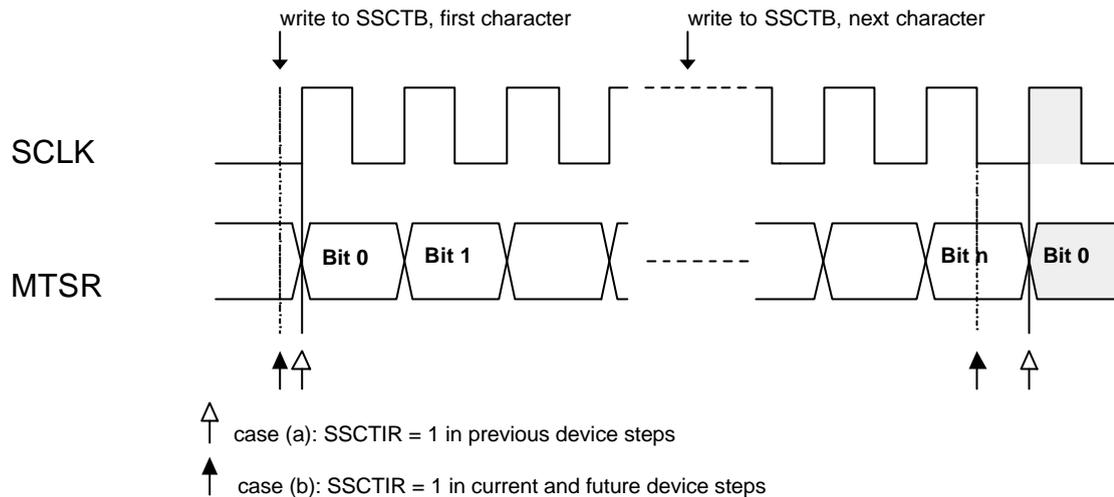
- before step **FA**, flag SSCTIR is set to '1' synchronous to the shift clock SCLK 1/2 bit time before the first latching edge (= first shifting clock edge when SSCPH = 0). When SSCTB is written while the shift register is empty, the maximum delay between the time SSCTB has been written and flag SSCTIR=1 is up to 1/2 bit time.
- beginning with step **FA**, when SSCTB has been written while the transmit shift register was empty (and the SSC is enabled), flag SSCTIR is set to '1' directly after completion of the write operation, independent of the selected baud rate. When the transmit shift register is not empty when SSCTB was written, SSCTIR is set to '1' after the last latching edge of SCLK (= 1/2 bit time before the first shifting edge of the next character). See also e.g. C167CR User's Manual V3.1, p. 12-5.

The following diagram shows these relations in an example for a data transfer in master mode with SSCPO = 0 and SSCPH = 0. It is assumed that the transmit shift register is empty at the time the first character is written to SSCTB:

Typically, in interrupt driven systems, no problems are expected from the modified timing of flag SSCTIR. However, when flag SSCTIR is polled by software in combination with other flags which are set/cleared at the end or at the beginning of a transfer (e.g. SSCBSY), the modified timing may have an effect.
